# Expanded Site Inspection

**CHEMETCO  
ILD 048 843 809  
*HARTFORD, ILLIOIS***

October 3, 2008

**Title:** CERCLA Expanded Site Inspection for Chemetco

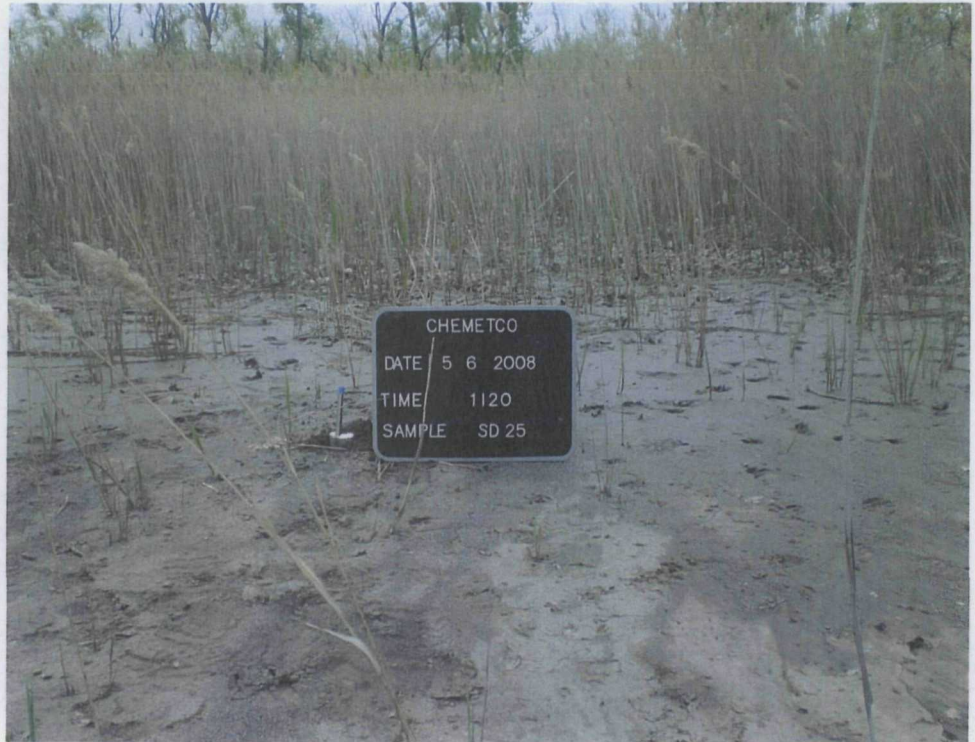
**COMMENTS:** SD25 correlates to X102. X102 was collected from the NE portion of the zinc oxide spill area. X102 consisted of a dark brown silty sand. X102 was collected from 0-6 inches.

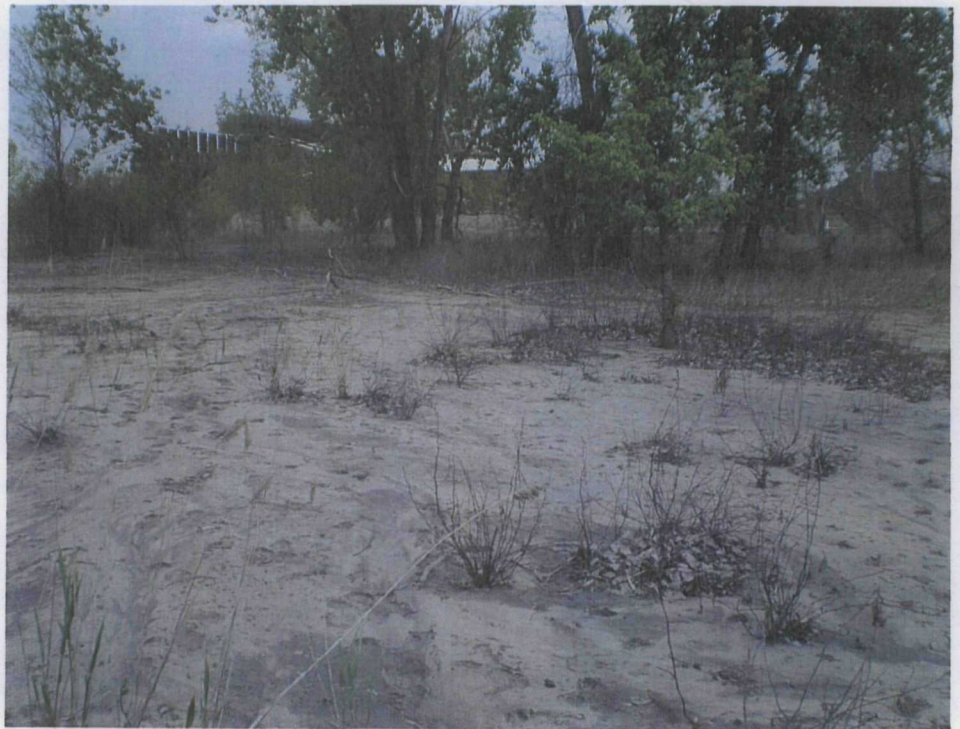
**COMMENTS:** Picture taken of the zinc oxide spill area from the southeastern corner of the spill area. Picture taken to the north, Chemetco in the background.

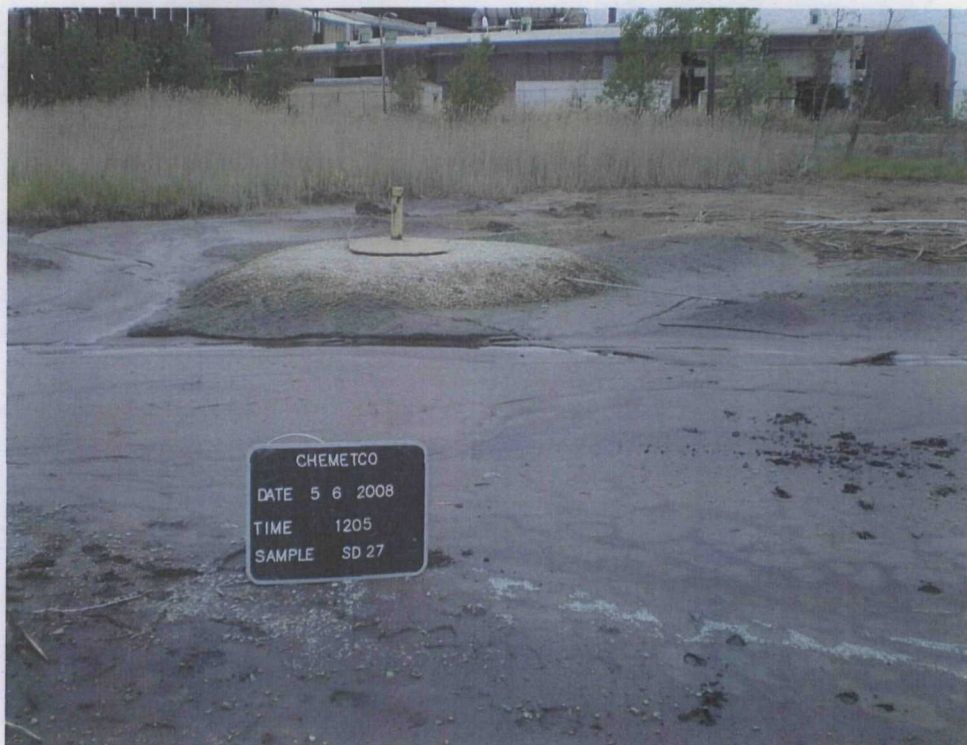
**COMMENTS:** SD27 correlates to X104. X104 was collected in the zinc oxide spill area, near the north end closer to Chemetco. Area was littered with green stained rocks. X104 consisted of a brown silty soil with green rocks. Collected from 0-2 inches.

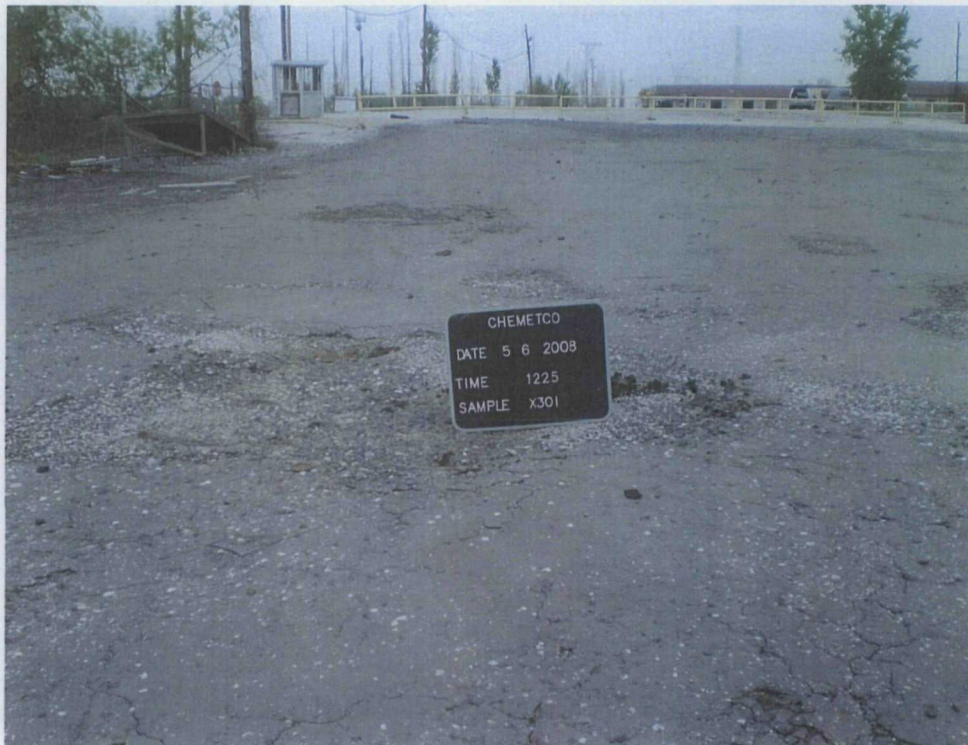
**COMMENTS:** X301 was collected from the slag covered asphalt area, just to the south of the main parking lot. X301 consisted of a black cindery gravel mix collected from a depth of 0-3 inches.

X302) were collected from this parking area and were found to contain significantly elevated levels of antimony, beryllium, cadmium, calcium, cobalt, copper, iron, lead, mercury, nickel, silver, sodium and zinc. There is no cap or liner to help prevent the contaminants from being spread off site via the air, groundwater or surface water pathways. The depth of the slag material with which the parking lot was made is unknown. At this time, there are rumors of spent refractory brick being buried/backfilled under the slag parking lot.

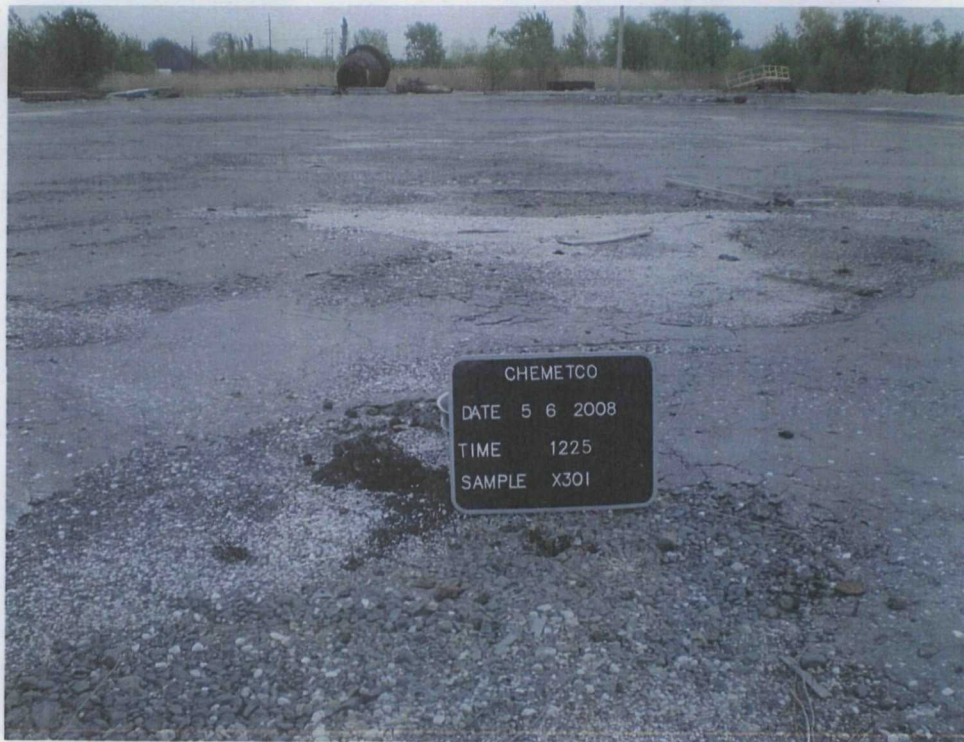
**COMMENTS:** X301 was collected from the slag covered asphalt area, just to the south of the main parking lot. X301 consisted of a black cindery gravel mix collected from a depth of 0-3 inches. Additional picture to show location.

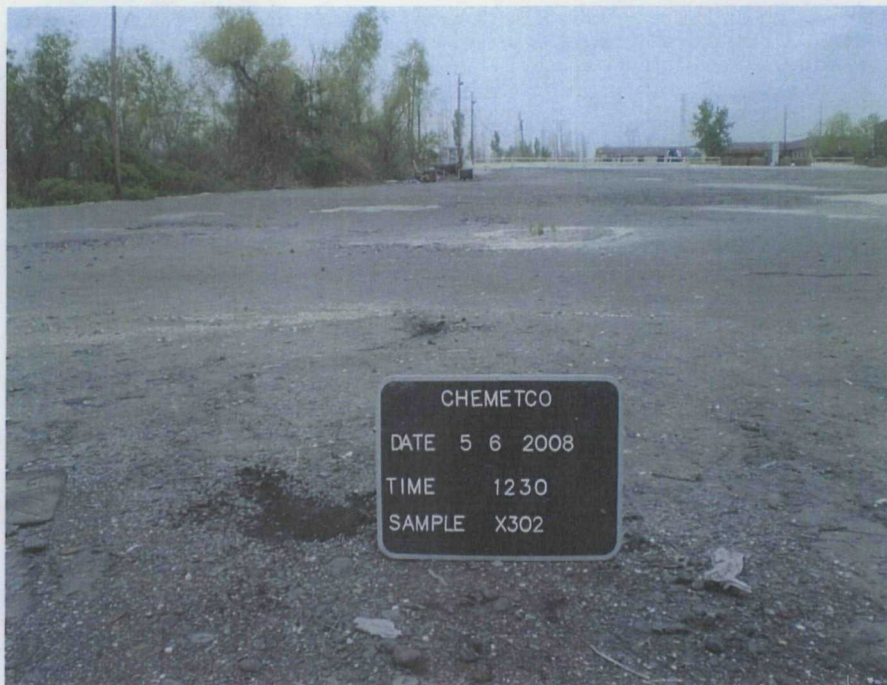
**COMMENTS:** X302 was collected in the slag parking area to the south of the main parking area. X302 consisted of a fine silty sandy material, not much cinders but with some metal pieces.

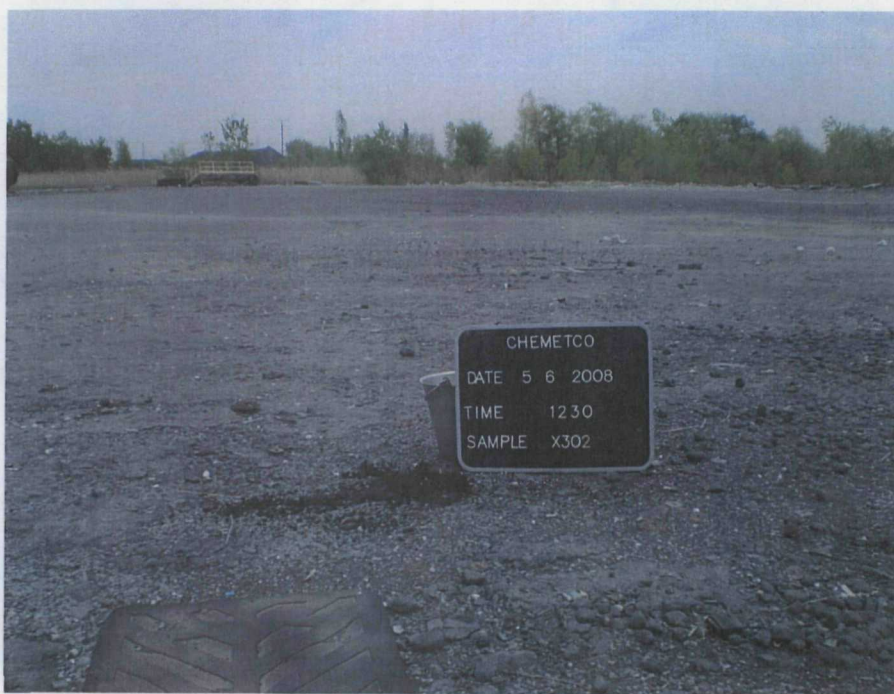
**COMMENTS:** X302 was collected in the slag parking area to the south of the main parking area. X302 consisted of a fine silty sandy material, not much cinders but with some metal pieces. Additional picture to show location.

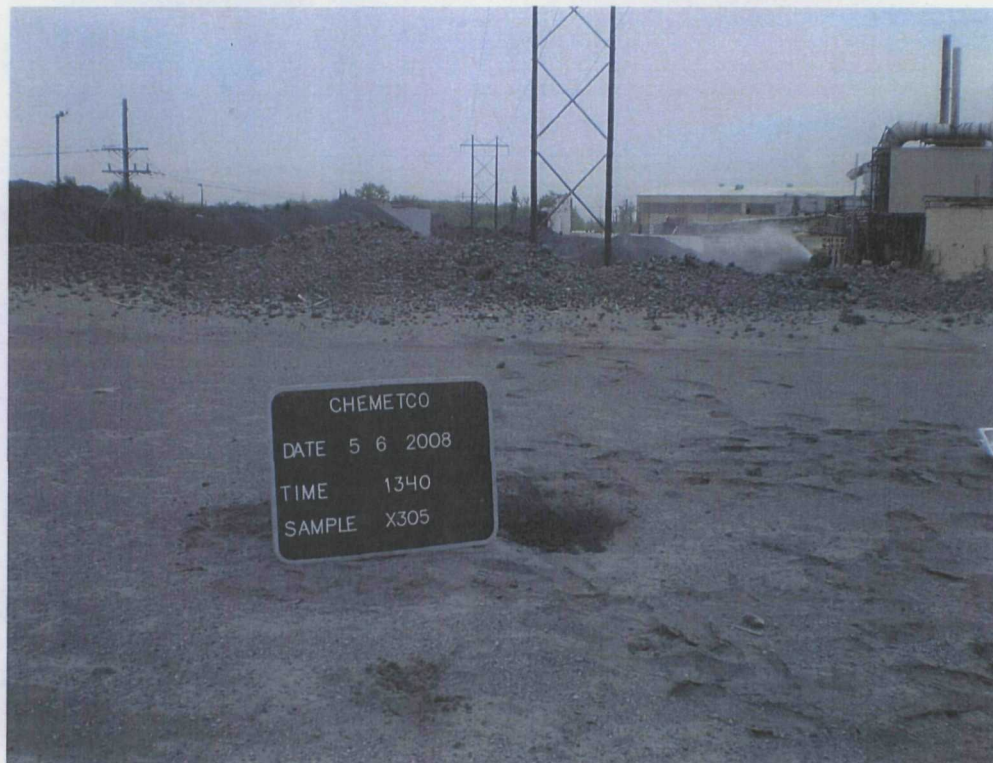
**COMMENTS:** X305 was collected from the east side of the zinc oxide pile (scrubber sludge). Sample consisted of a sandy brown material. Sample was collected from 2-4 inches.

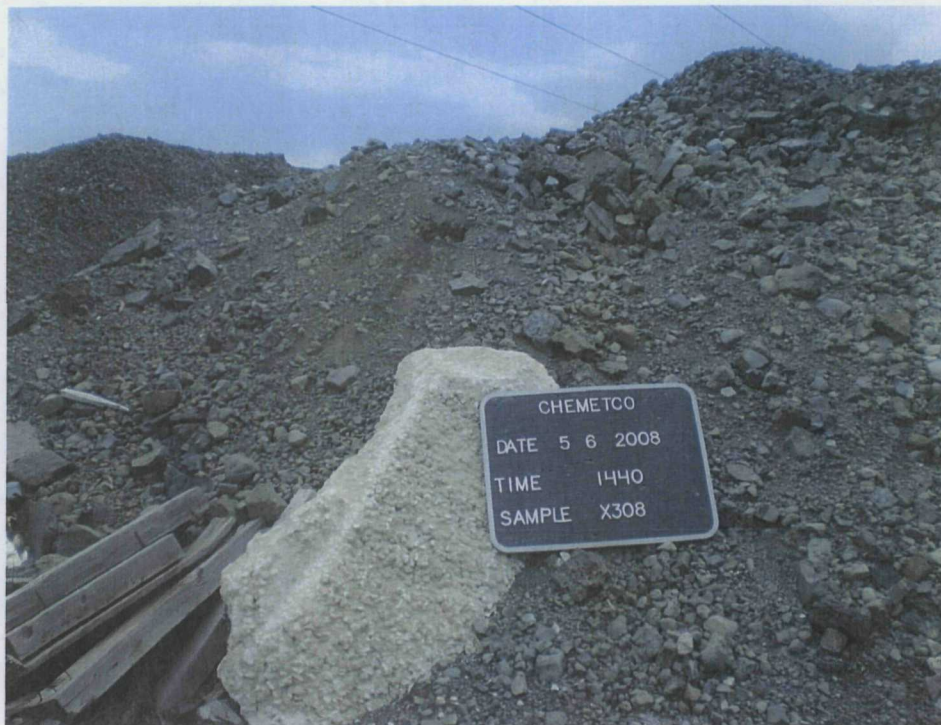
**COMMENTS:** X308 was collected from the south side of the site from fine located in the south slag pile. X308 was collected from a depth of 0-3 inches and consisted of a fine gray slag material with some reddish material mixed in.

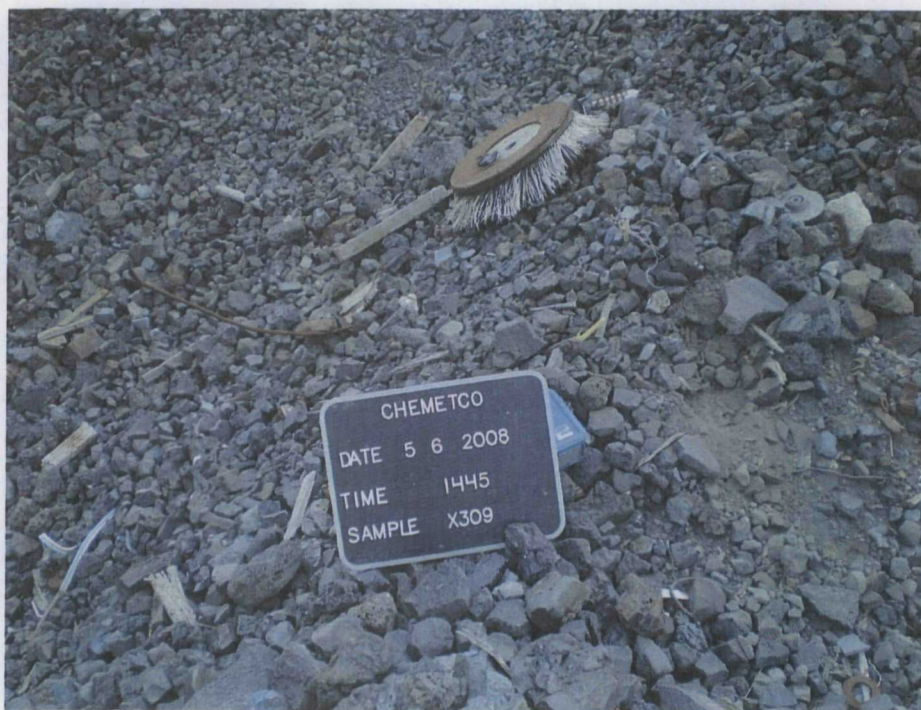
**COMMENTS:** X309 was collected from the south slag pile from a dusty slag material with metal debris. X309 was collected from a depth of 0-2 inches.

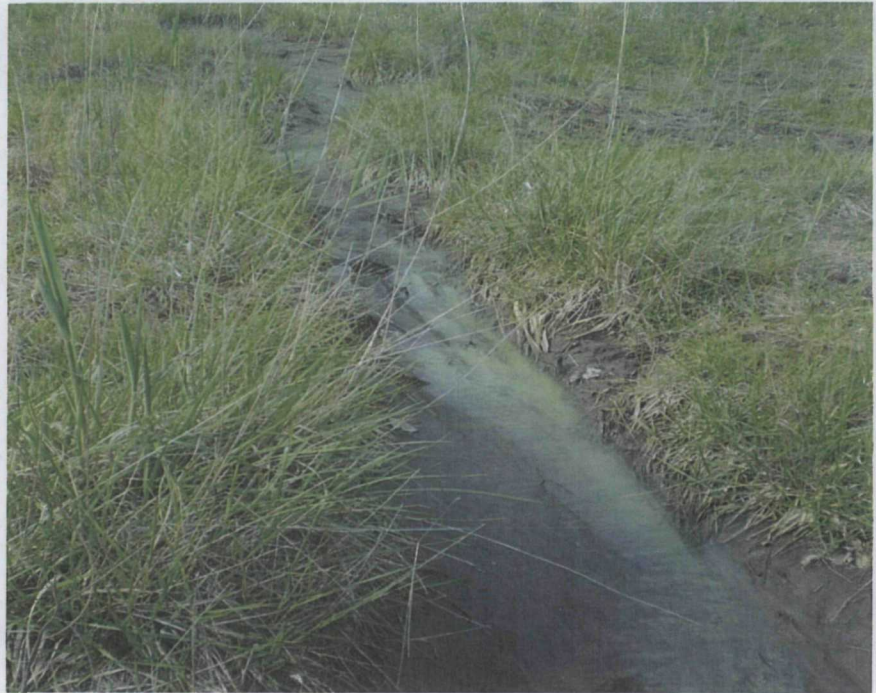
**COMMENTS:** Photo taken of drainage in the zinc oxide spill area. Notice the light green scum in the flowing water. This scum was not moss or vegetation. Color is similar to tarnished copper.

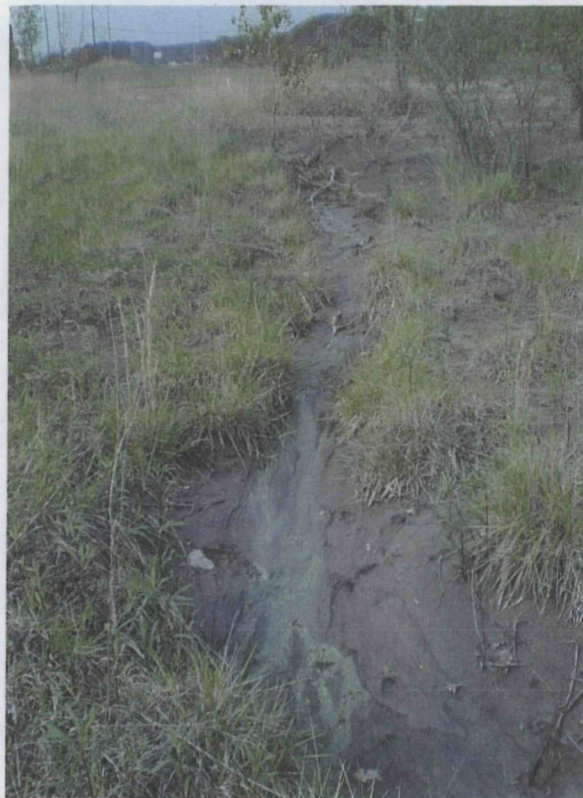
**COMMENTS:** Photo taken of drainage in the zinc oxide spill area. Notice the light green scum in the flowing water. This scum was not moss or vegetation. Color is similar to tarnished copper.

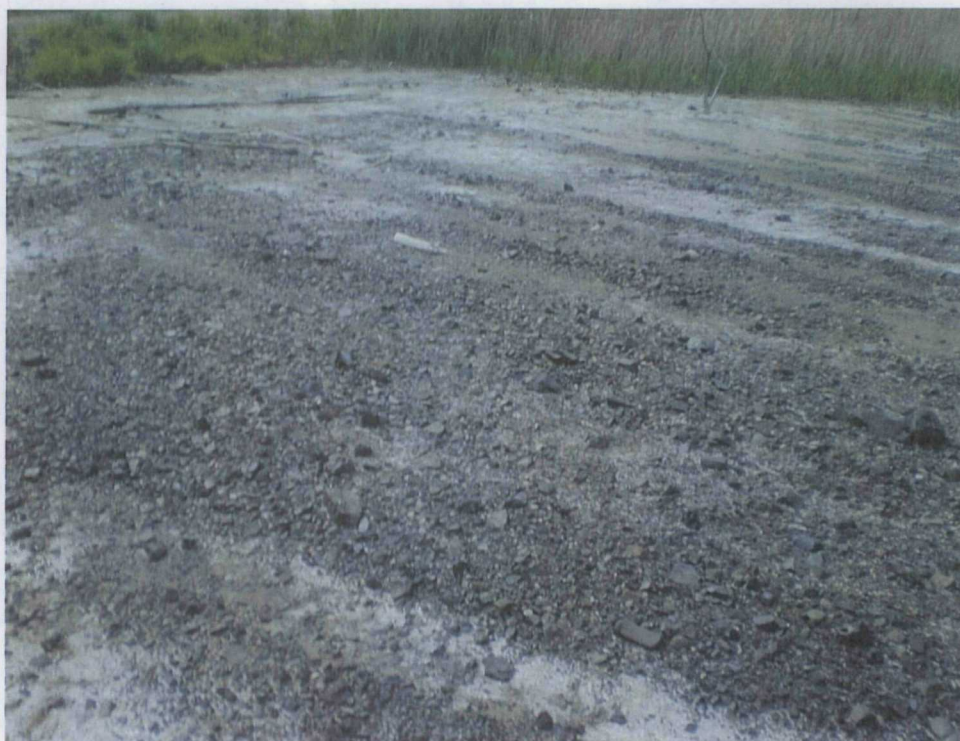
Picture taken of the  
zinc oxide spill area.

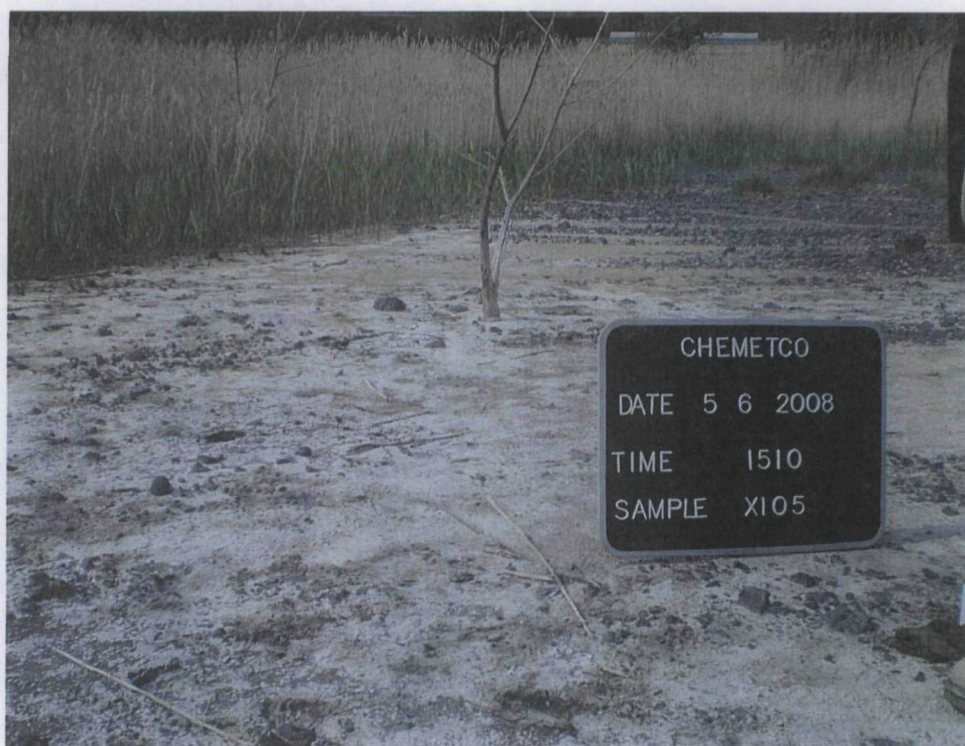
**COMMENTS:** X105  
was collected from the  
zinc oxide spill area.  
Sample consisted of a  
light brown silty  
material. Sample depth  
was 0-6 inches.

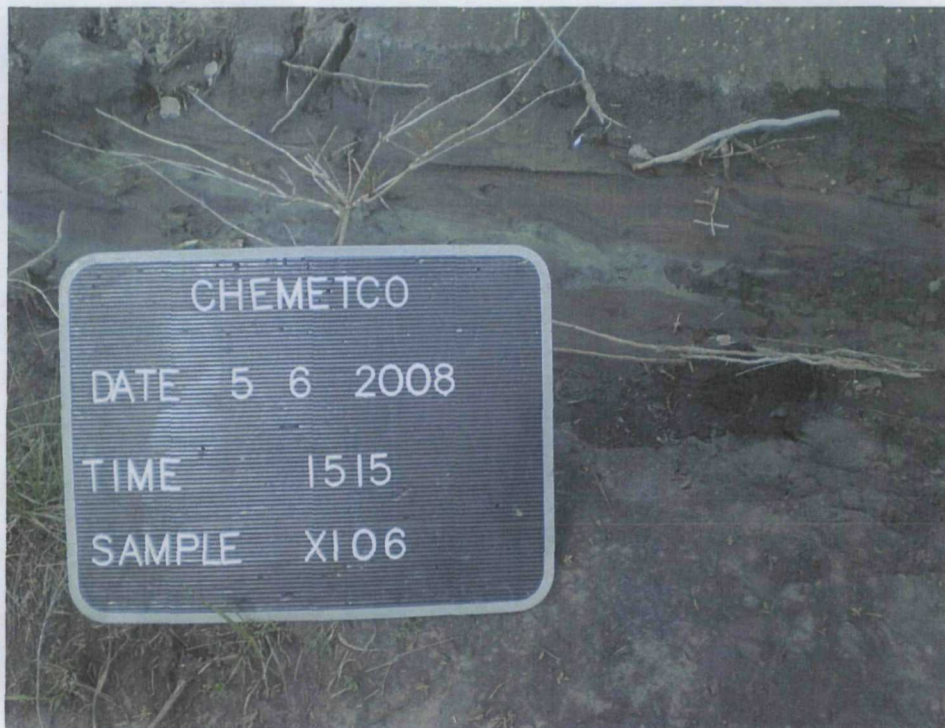
**COMMENTS:** X106 was collected from a shallow gulley in the zinc oxide spill area containing a green stain. X106 consisted of dark brown silty material with green staining. Sample depth was 0-2 inches.

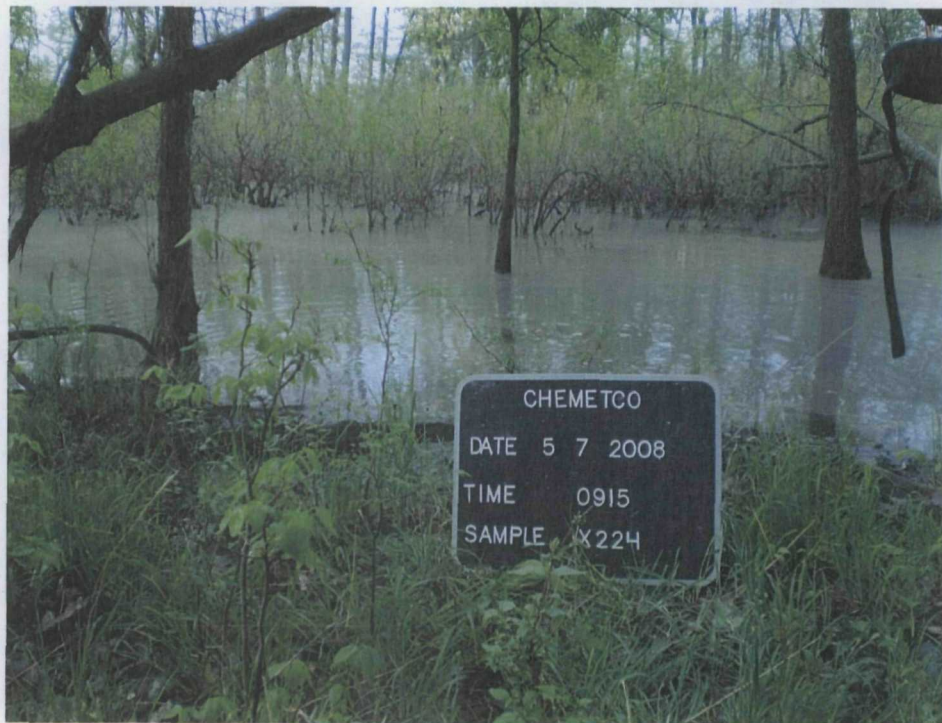
**COMMENTS:** X224 was collected from the sediments of the drainage area to the east of the site. X224 consisted of a silty clay mix and was collected from 0-6 inches.

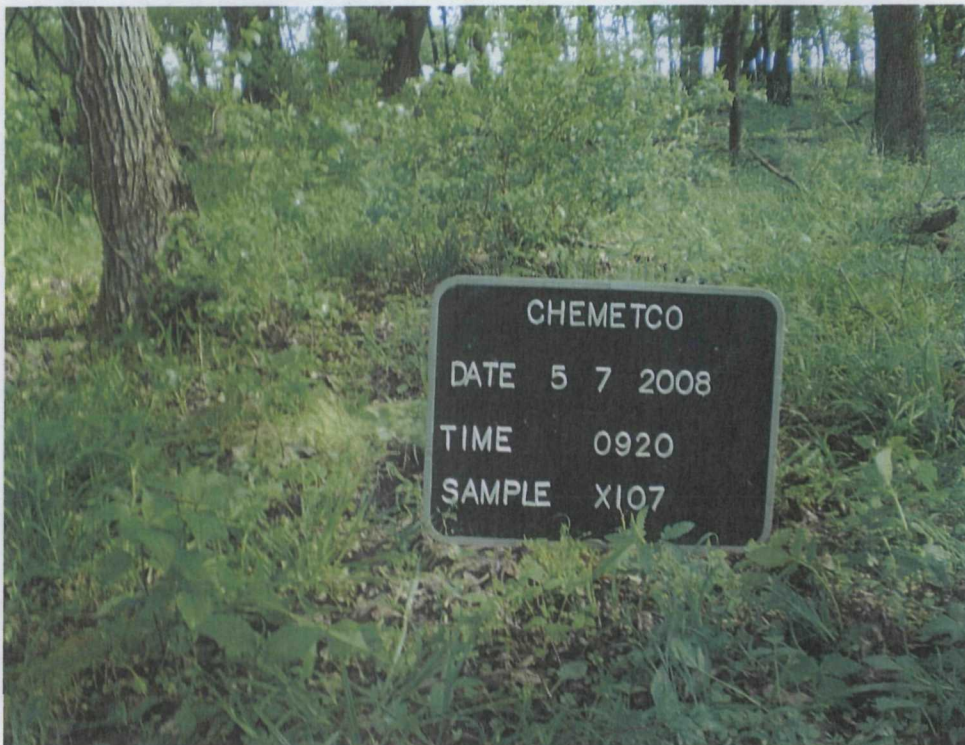
**COMMENTS:** X107 was collected in the woods to the west of Chemetco. Sample was collected from a depth of 0-6 inches and consisted of a light brown silty soil.

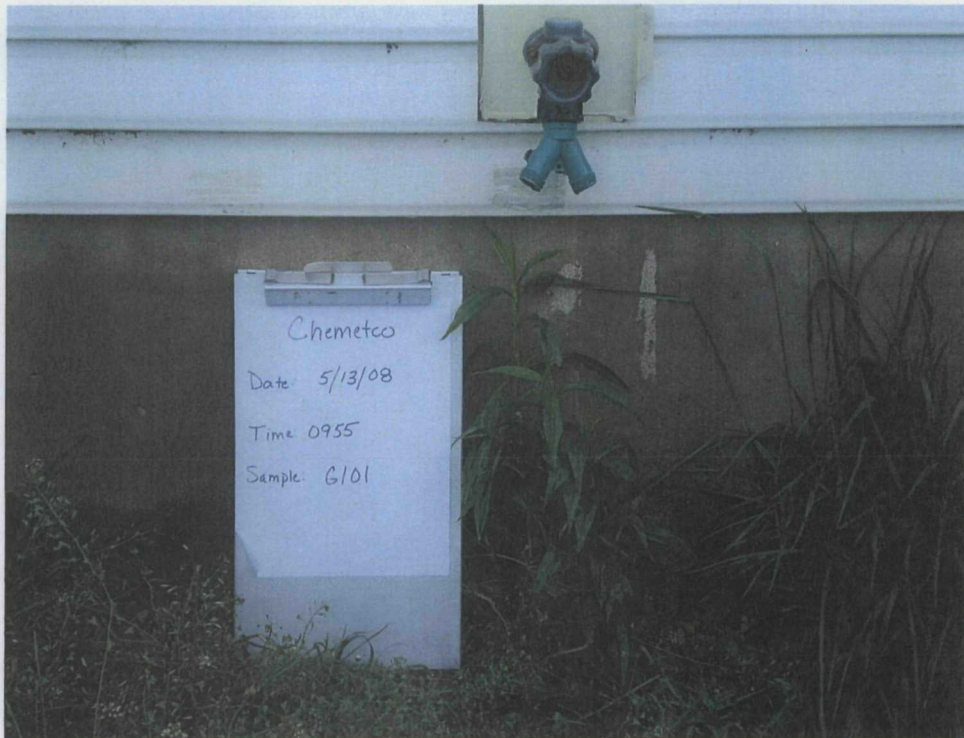
**COMMENTS:** G101 was collected from a residential well located to the north of Chemetco. Sample was collected from an outside spigot. Well is 55 ft deep and was installed in April 2008. Only filtered water available.

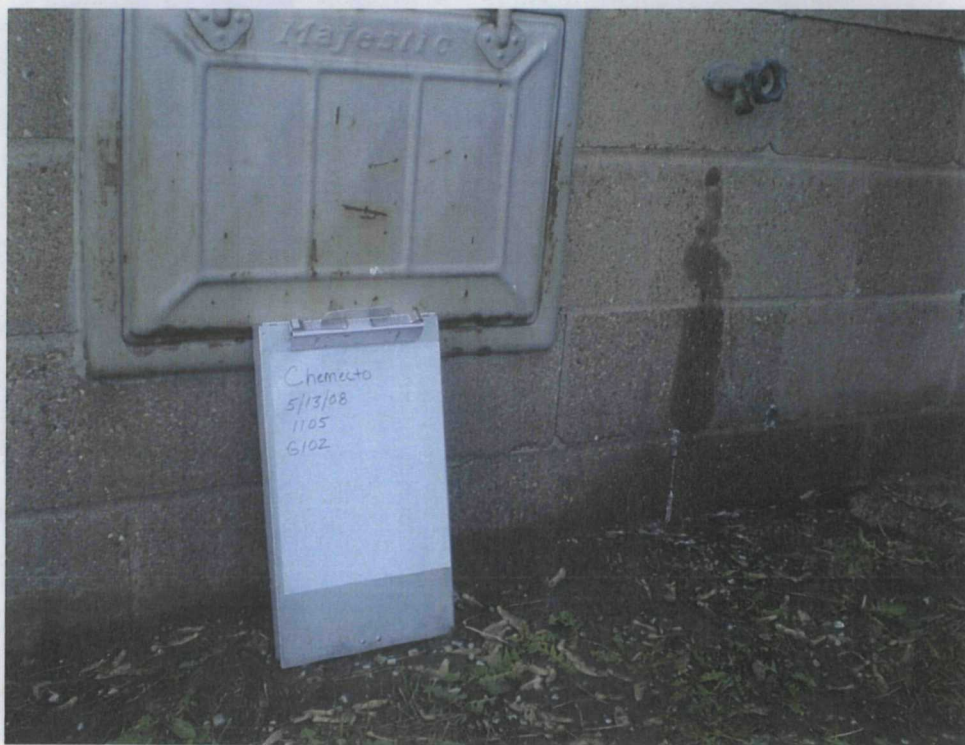
**COMMENTS:** G102 was collected from a residential well located to the north of Chemetco. Depth of this well was unknown.

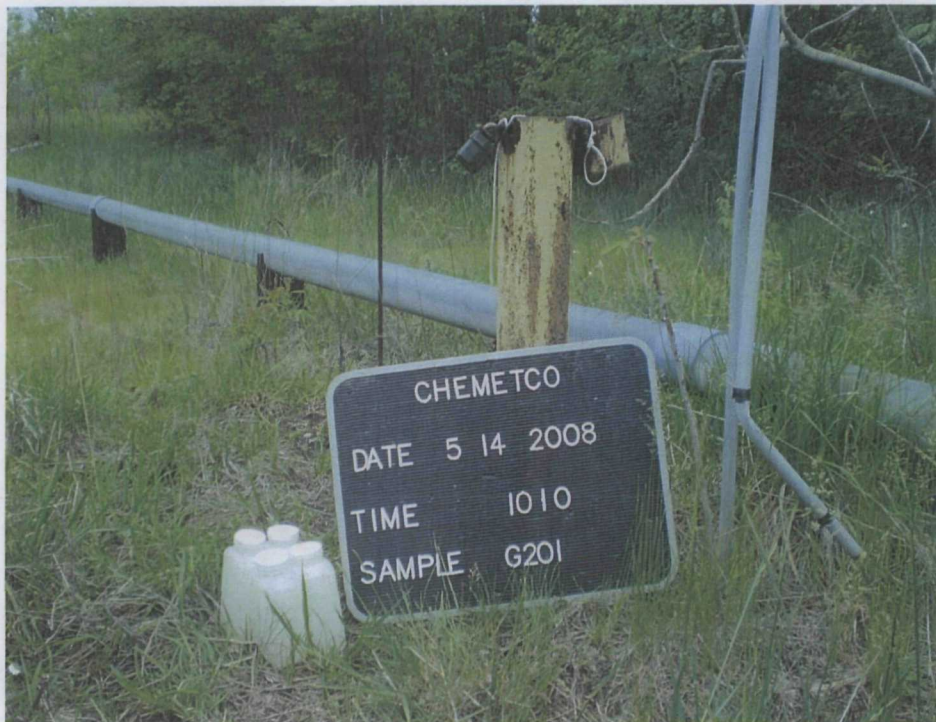
**COMMENTS:** G201 was collected from a monitoring well (MW 41) located to the east of Chemetco. According to Chemetco personnel this was a background location. Depth to water from ground was 12.6 feet. Well depth was 21.9 feet.

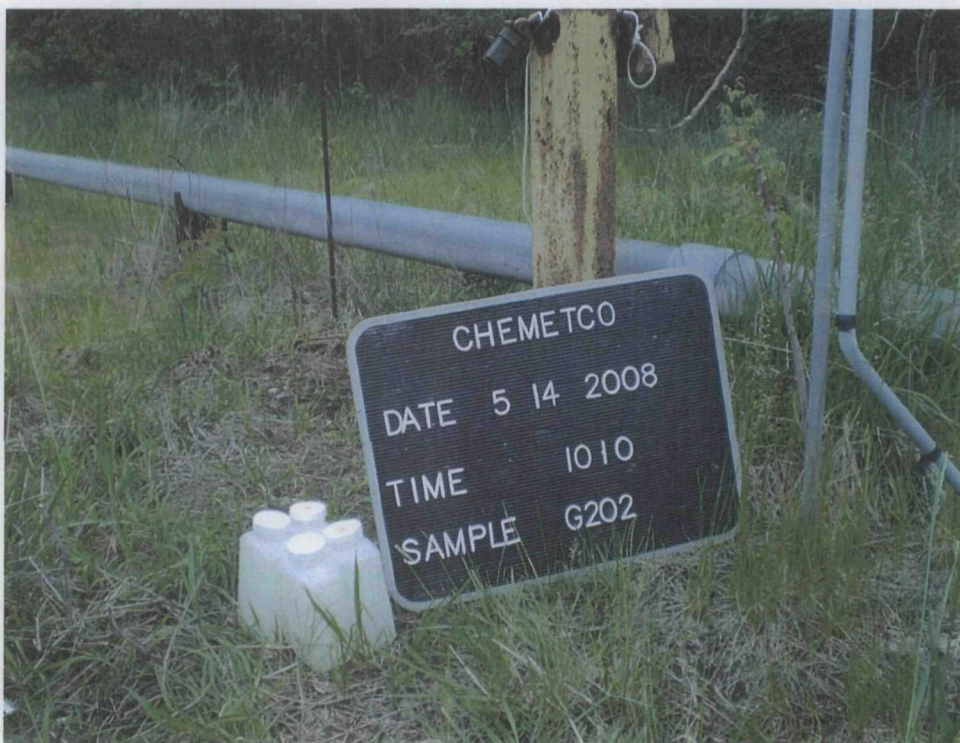
**COMMENTS:** G202 (dup) was collected from a monitoring well (MW 41) located to the east of Chemetco. According to Chemetco personnel this was a background location. Depth to water from ground was 12.6 feet. Well depth was 21.9 feet.

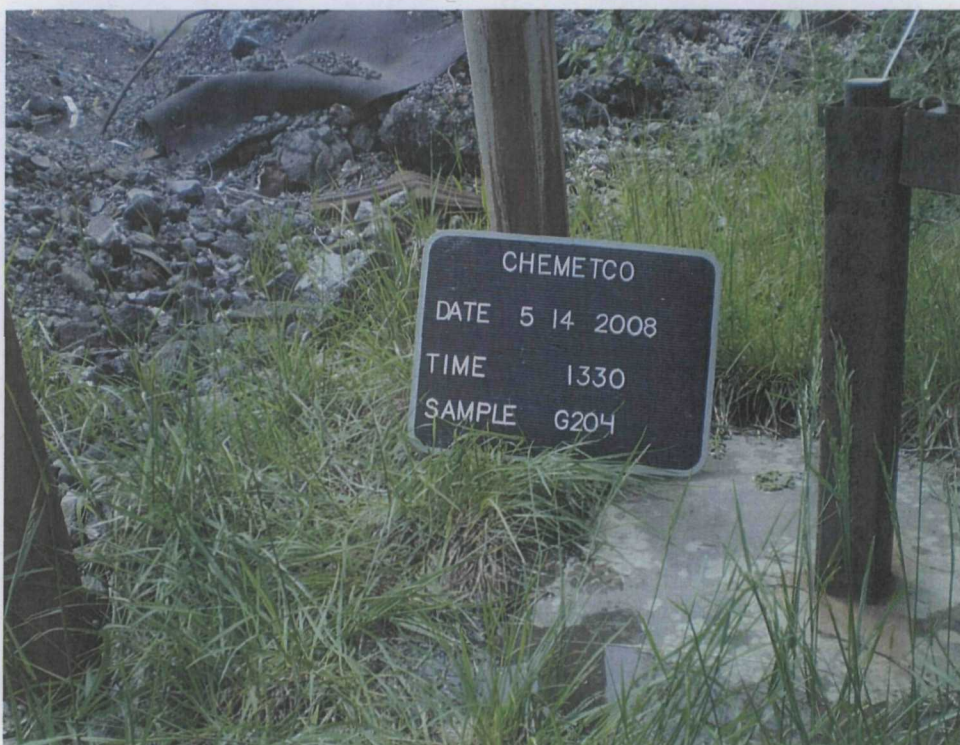
**COMMENTS:** G204 was collected from MW 47R which is located on the north side of Chemetco inside the fence. Well depth was 50.25 feet with water located 18.05 feet from surface.
